# INSPECTION REPORT

For the Property at:  
**1 ANY STREET**  
TORONTO, ON L8T 1A1

Prepared for: JANE DOE  
Inspection Date: Friday, November 22, 2024  
Prepared by: Sid Ford

Report No. 1081, v.0

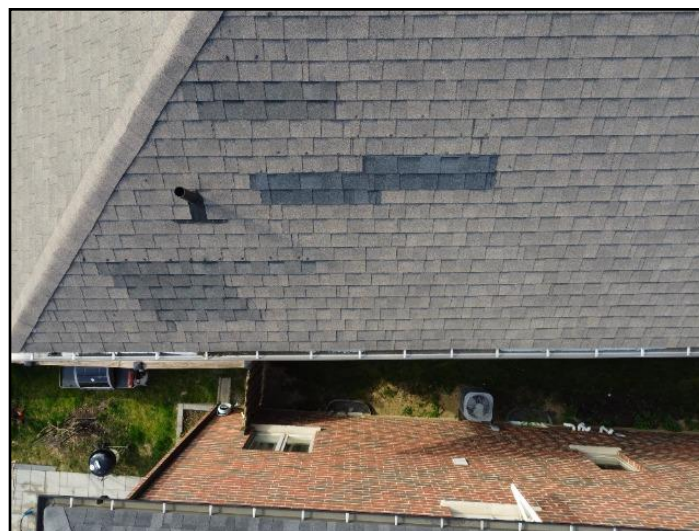
**Condition:** • [Patched](#)

Patched areas indicate areas of previous roofing/shingle issues. It is not always possible to determine the performance of the repair.

**Implication(s):** Chance of water damage to structure, finishes and contents

1. Patched shingle area

**Task:** Monitor for leaks

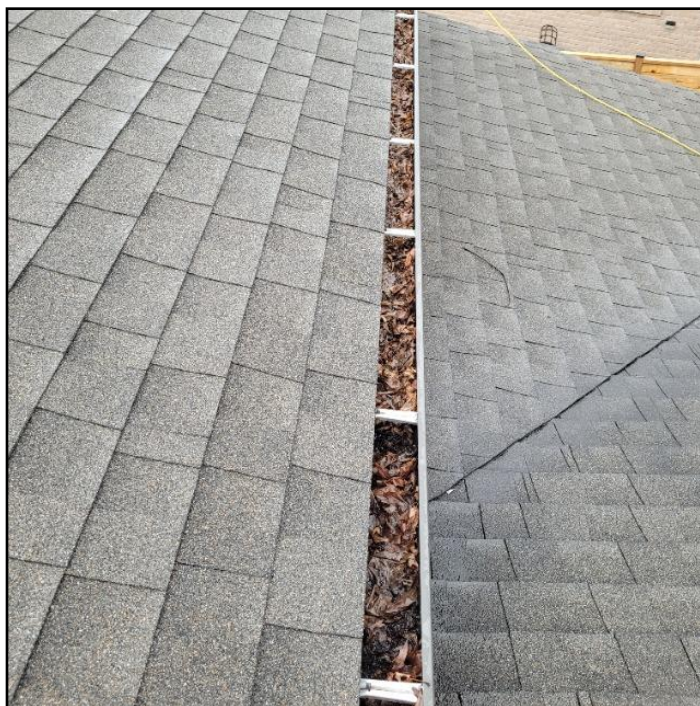
**Condition:** • [Clogged](#)

**Implication(s):** Chance of water damage to structure, finishes and contents

2. Clogged Gutters

Clean and ensure that any joints susceptible to leaking are properly sealed.

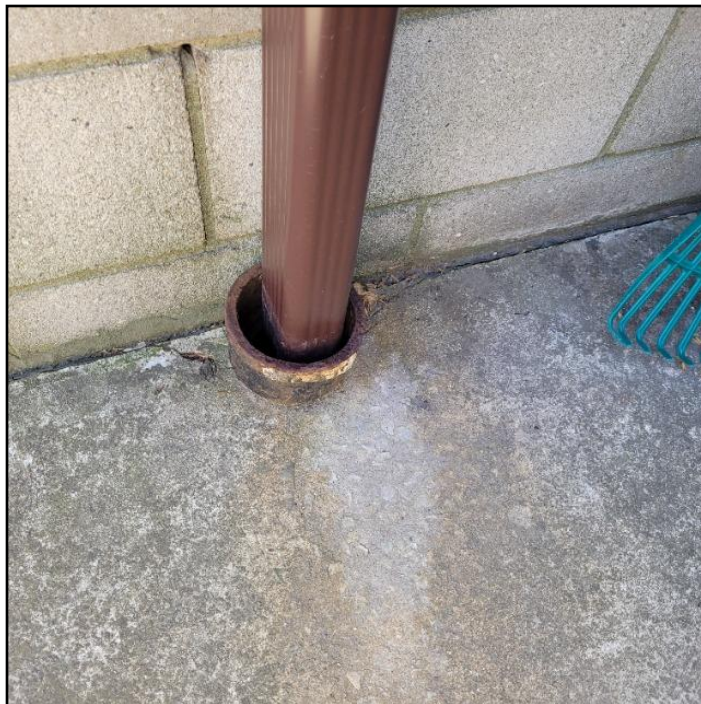
**Condition:** • Discharge below grade

**Implication(s):** Chance of water damage to structure, finishes and contents

3. Discharge below grade

Recommend cap off below grade downspout, add elbow to existing downspout and 6' to 10' of horizontal extension to downspout. This recommendation is not an installation defect, but is noted as an improvement to reduce the likelihood of blockages in the buried drainage system. Refer to your local city or municipal building department for any specific requirements or guidelines.

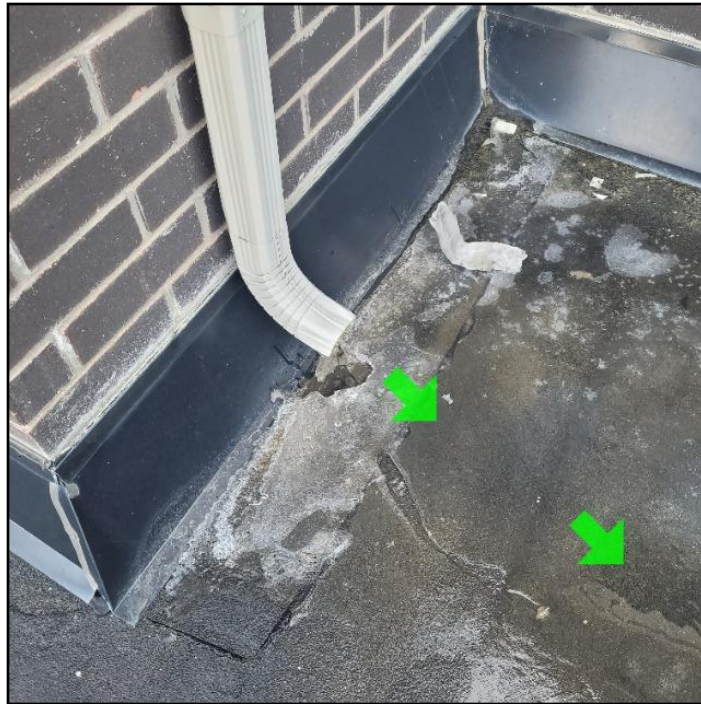
**Condition:** • Discharge too close to building

**Implication(s):** Chance of water damage to structure, finishes and contents

4. Discharge too close to building

Recommend adding a horizontal downspout extension with a good slope. Discharge should be at least 4' to 6' away from the foundation wall.

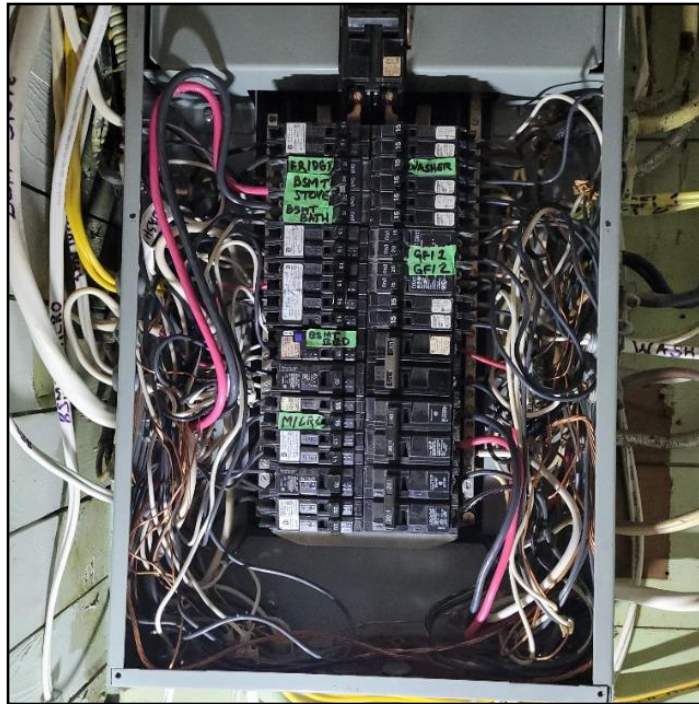
**Condition:** • [Crowded](#)

The electrical distribution panel was extremely overcrowded and represented a severe safety hazard. The services of a licensed electrician is recommended to assess the panel, trace, clean up and properly route the circuits, or consider sub-panel or upgrade.

**Implication(s):** Electric shock | Fire hazard

5. Overcrowded

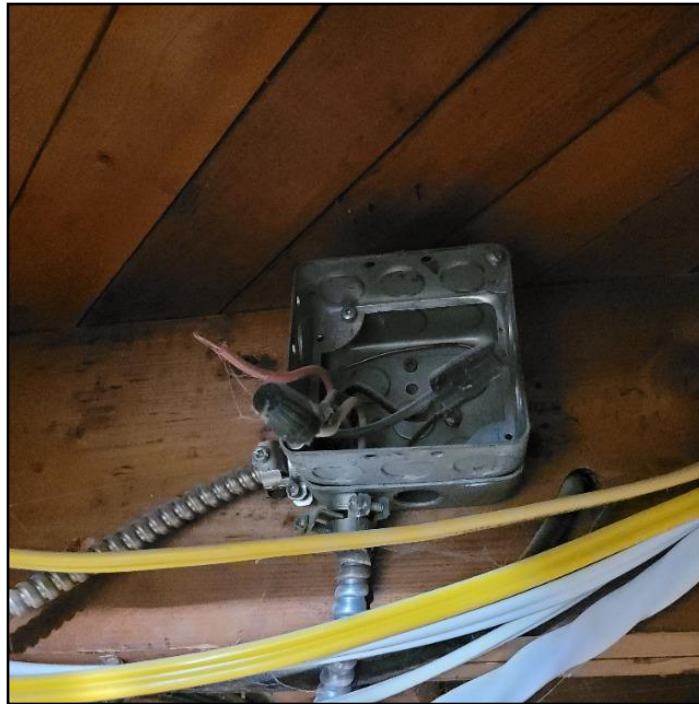
**Condition:** • [Cover loose or missing](#)

**Implication(s):** Electric shock | Fire hazard

6. Cover missing

**Task:** Provide junction box cover

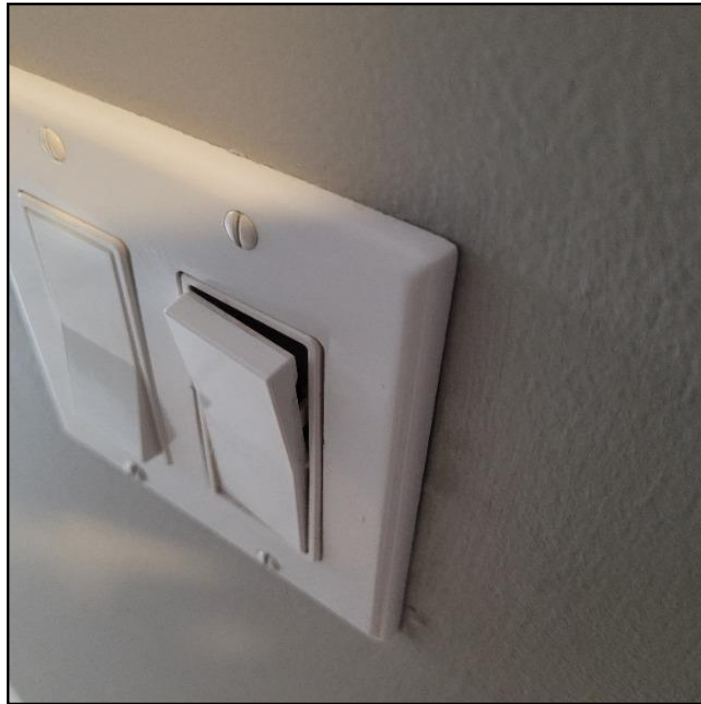
**Condition:** • [Damage](#)

**Implication(s):** Electric shock | Fire hazard

7. Damaged switch

**Task:** Replace

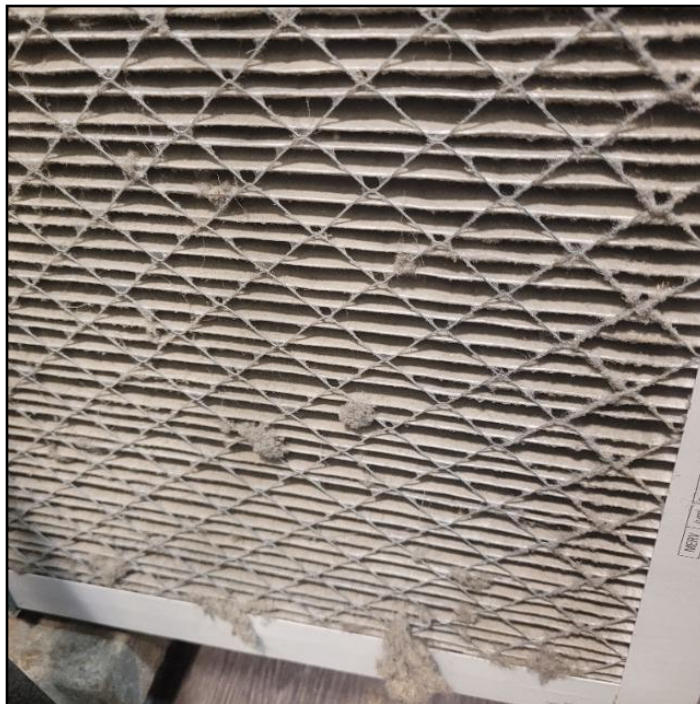
**Condition:** • [Dirty](#)

**Implication(s):** Equipment ineffective | Increased heating costs | Reduced comfort | Increased maintenance costs

8. Dirty air filter

**Task:** Replace

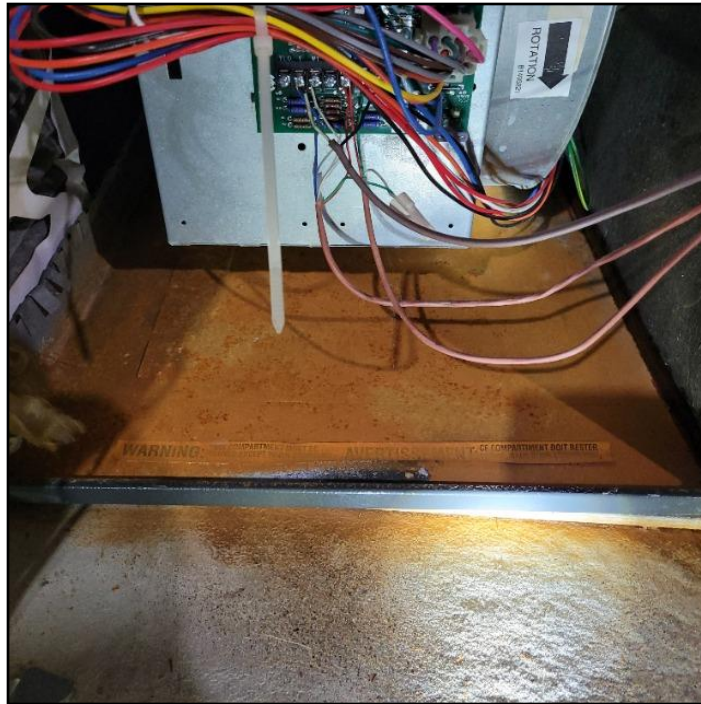
**Condition:** • [Rust](#)

Note: Exterior rust may not always be a major concern, if the integrity of the cabinet is functioning as intended. Internal rust may be caused by other factors that may require the services of a licensed HVAC technician to inspect and determine the cause and recommend the appropriate course of action.

**Implication(s):** Material deterioration | Reduced system life expectancy

9. Rust in cabinet

**Task:** Further evaluation

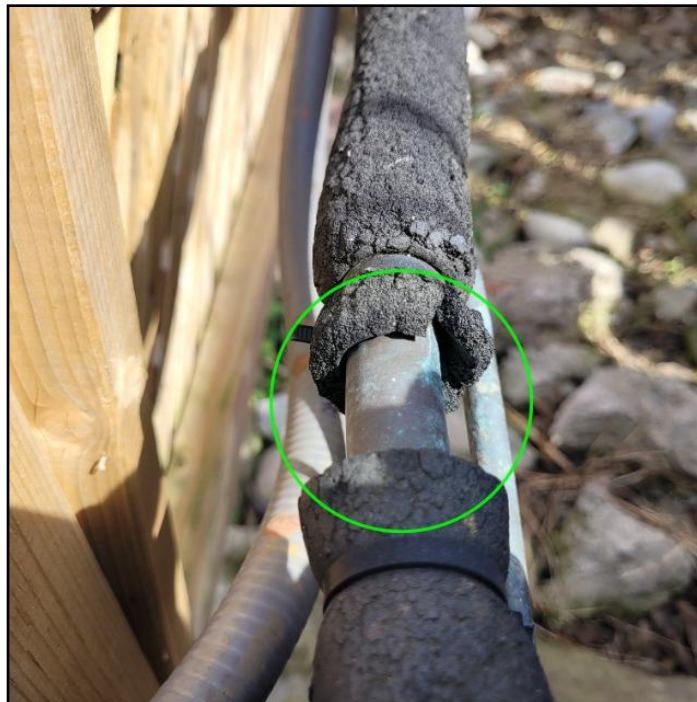
**Condition:** • [Insulation - missing](#)

**Implication(s):** Reduced system life expectancy | Increased cooling costs | Reduced comfort

10. Insulation - missing

**Task:** Repair

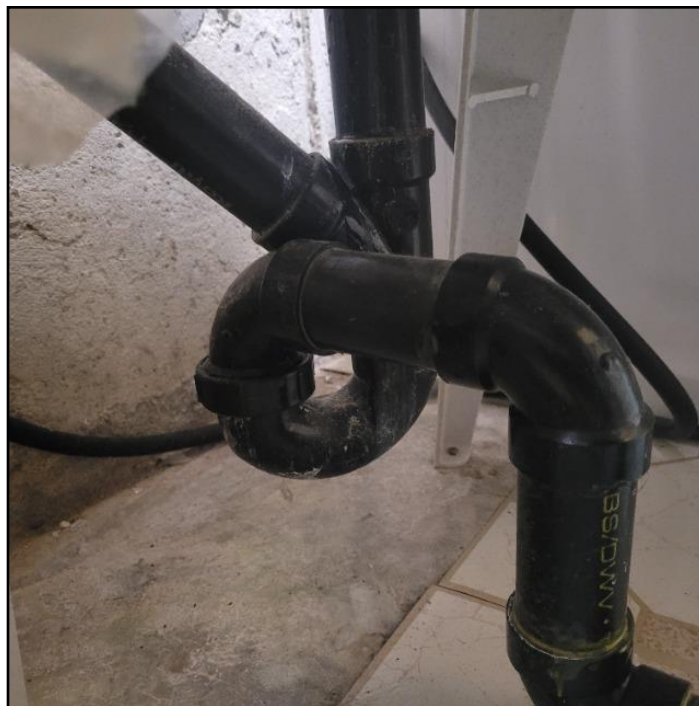
**Condition:** • [Nonstandard shape or material](#)

**Implication(s):** Reduced operability | Fixtures slow to drain

11. Nonstandard trap installation

**Task:** Correct

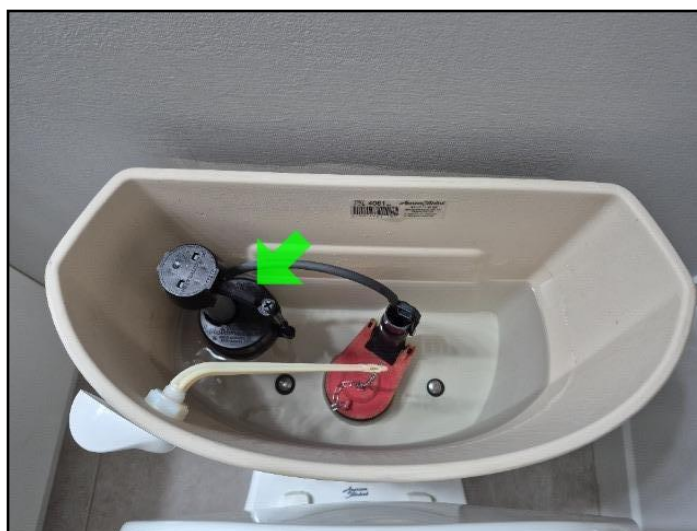
Condition: • [Flush mechanism inoperative](#)

**Implication(s):** Equipment failure | Sewage entering the building

12. Flush mechanism inoperative

**Task:** Replace

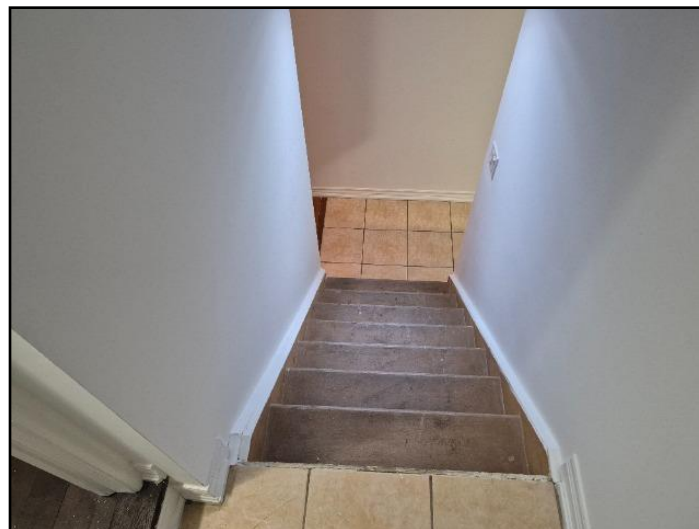
**Condition:** • [Missing](#)

**Implication(s):** Fall hazard

14. Missing handrail

**Task:** Provide
