# INSPECTION REPORT

For the Property at:  
**1 ANY STREET**  
TORONTO, ON L8T 1A1

Prepared for: JANE DOE  
Inspection Date: Friday, November 22, 2024  
Prepared by: Sid Ford

Report No. 1081, v.0

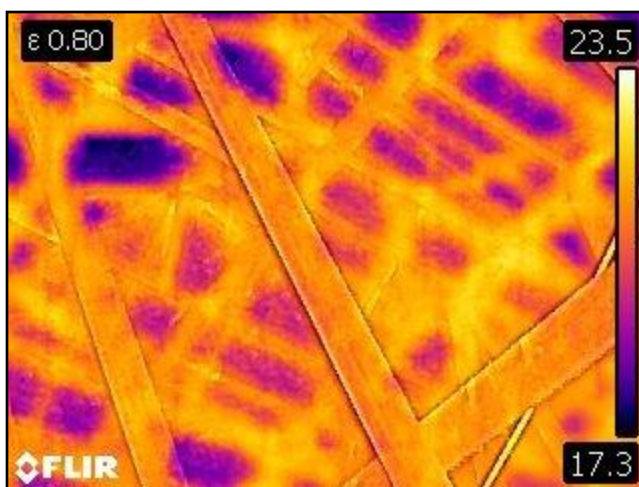
13. Roof space - Thermal image

**Condition:** • NOTE: The interior was inspected with thermal imaging. These cameras use infrared technology to detect surface temperature variations not visible to the naked eye. Thermal imaging is used to detect: electrical hazards such as overheated circuits, air leaks around windows/doors and identifying missing or damaged insulation. Thermal imaging can detect cooler spots indicative of water intrusion within the building structure, (walls, ceilings, foundation) often caused by plumbing or roof leaks. Where possible, any observation/recommendation taken by a thermal imaging camera, will be included in the report alongside the comparable original image.
